DEPARTMENT OF THE ARMY
UNITED STATES ARMY AVIATION TEST BOARD
Fort Rucker, Alabama 36360

SUBJECT: Letter Report, Armed and Armored Chinook Safety-Release
and Weapon-Verification Testing, USATECOM Project No.
4-5-2010-07

24 MAR 1966

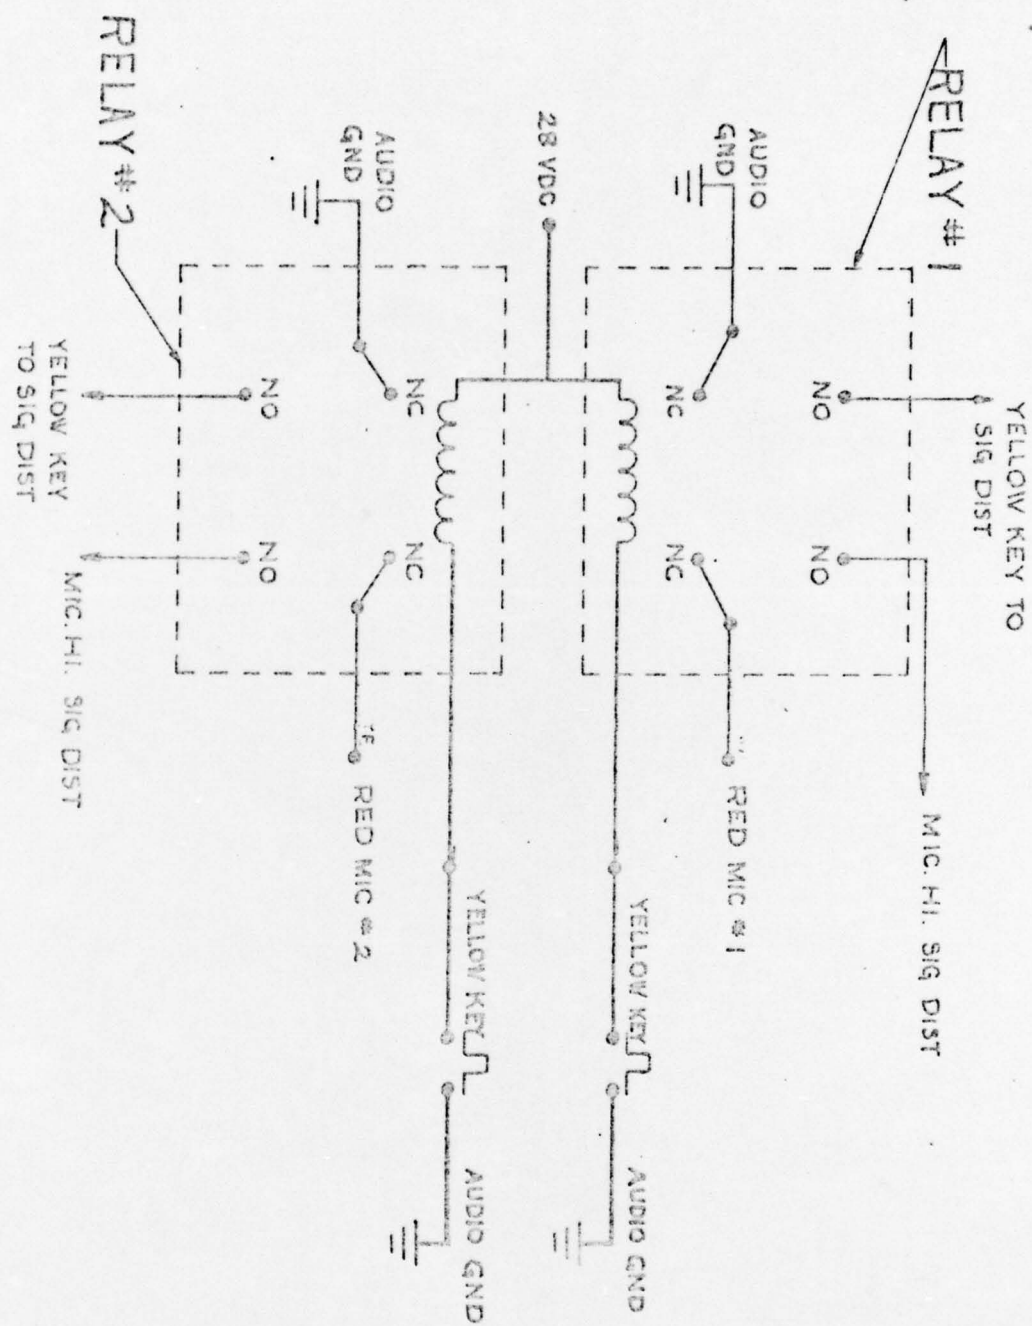
INDIVIDUAL KEYING CIRCUIT
FOR GUNNER'S INTERCOM
IN UH-1B, D HELICOPTERS

the helicopter, could not be achieved using the standard Army APH-5 helmet. An APH-5 helmet was modified with ear protector muffs, Model ASP-184, manufactured by David Clark Co., Inc. and with a directional microphone, FSN 5965-680-9798. The loss of communication between the gunners and other crewmembers is caused partially from both gunners using a common signal distribution amplifier. As a result, when one gunner "keyed" to talk, the other gunner's microphone was also energized, thus picking up twice the ambient noise (wind, rotor, transmission, engine, etc.) and causing an impedance mismatch to the amplifier. To eliminate keying of both microphones by one gunner and to make communication possible, a miniature 28 v.d.c. relay, FSN 5945-837-5318 (Incl 1) was installed in series with each gunner's microphone and key line to permit individual keying by each gunner.

c. The installation of the relays in series with each gunner's microphone line makes communication possible from the gunners to other crewmembers.

6. Conclusions. It is concluded that communication problems can be significantly reduced by the construction of a sound attenuating helmet with a highly directional microphone and installation of the miniature 28 v.d.c. relay.
